USS ARIZONA MEMORIAL and PEARL HARBOR NATIONAL HISTORIC LANDMARK

SUBMERGED CULTURAL RESOURCES STUDY

by Daniel J. Lenihan, Editor Principal Investigator Submerged Cultural Resources Unit

Southwest Cultural Resources Center Professional Papers No. 23

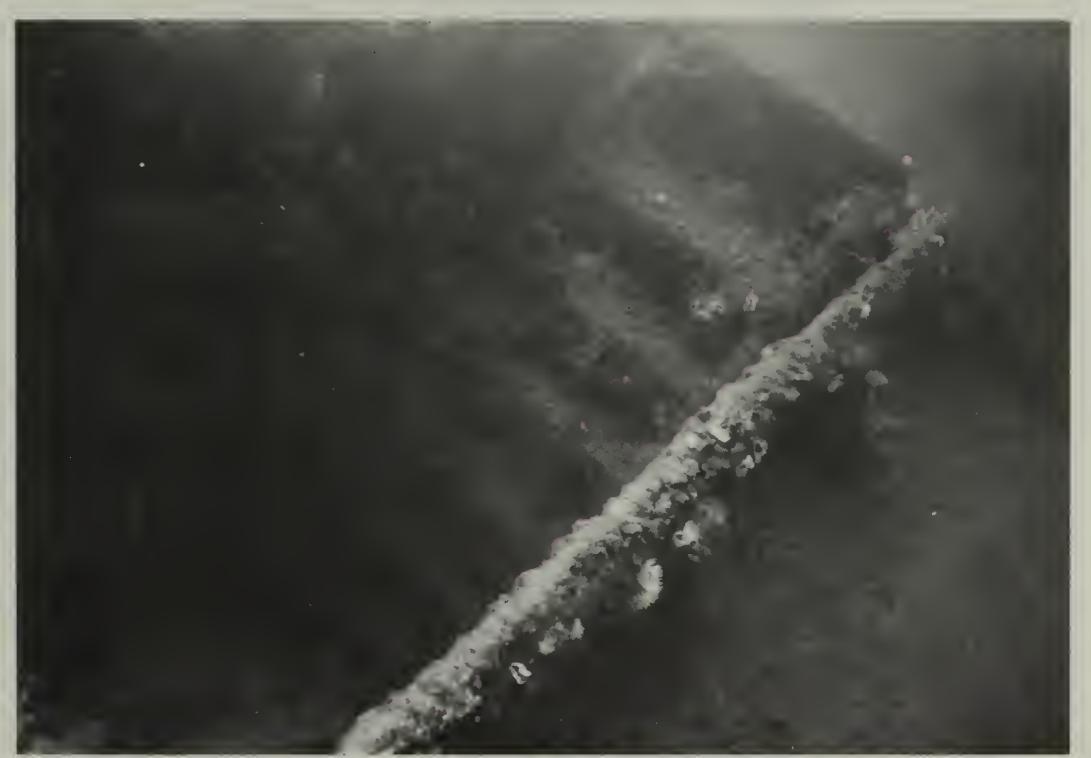
Figure 3.31. Stairs lead down into interior of USS UTAH. (NPS photo by Larry Murphy)

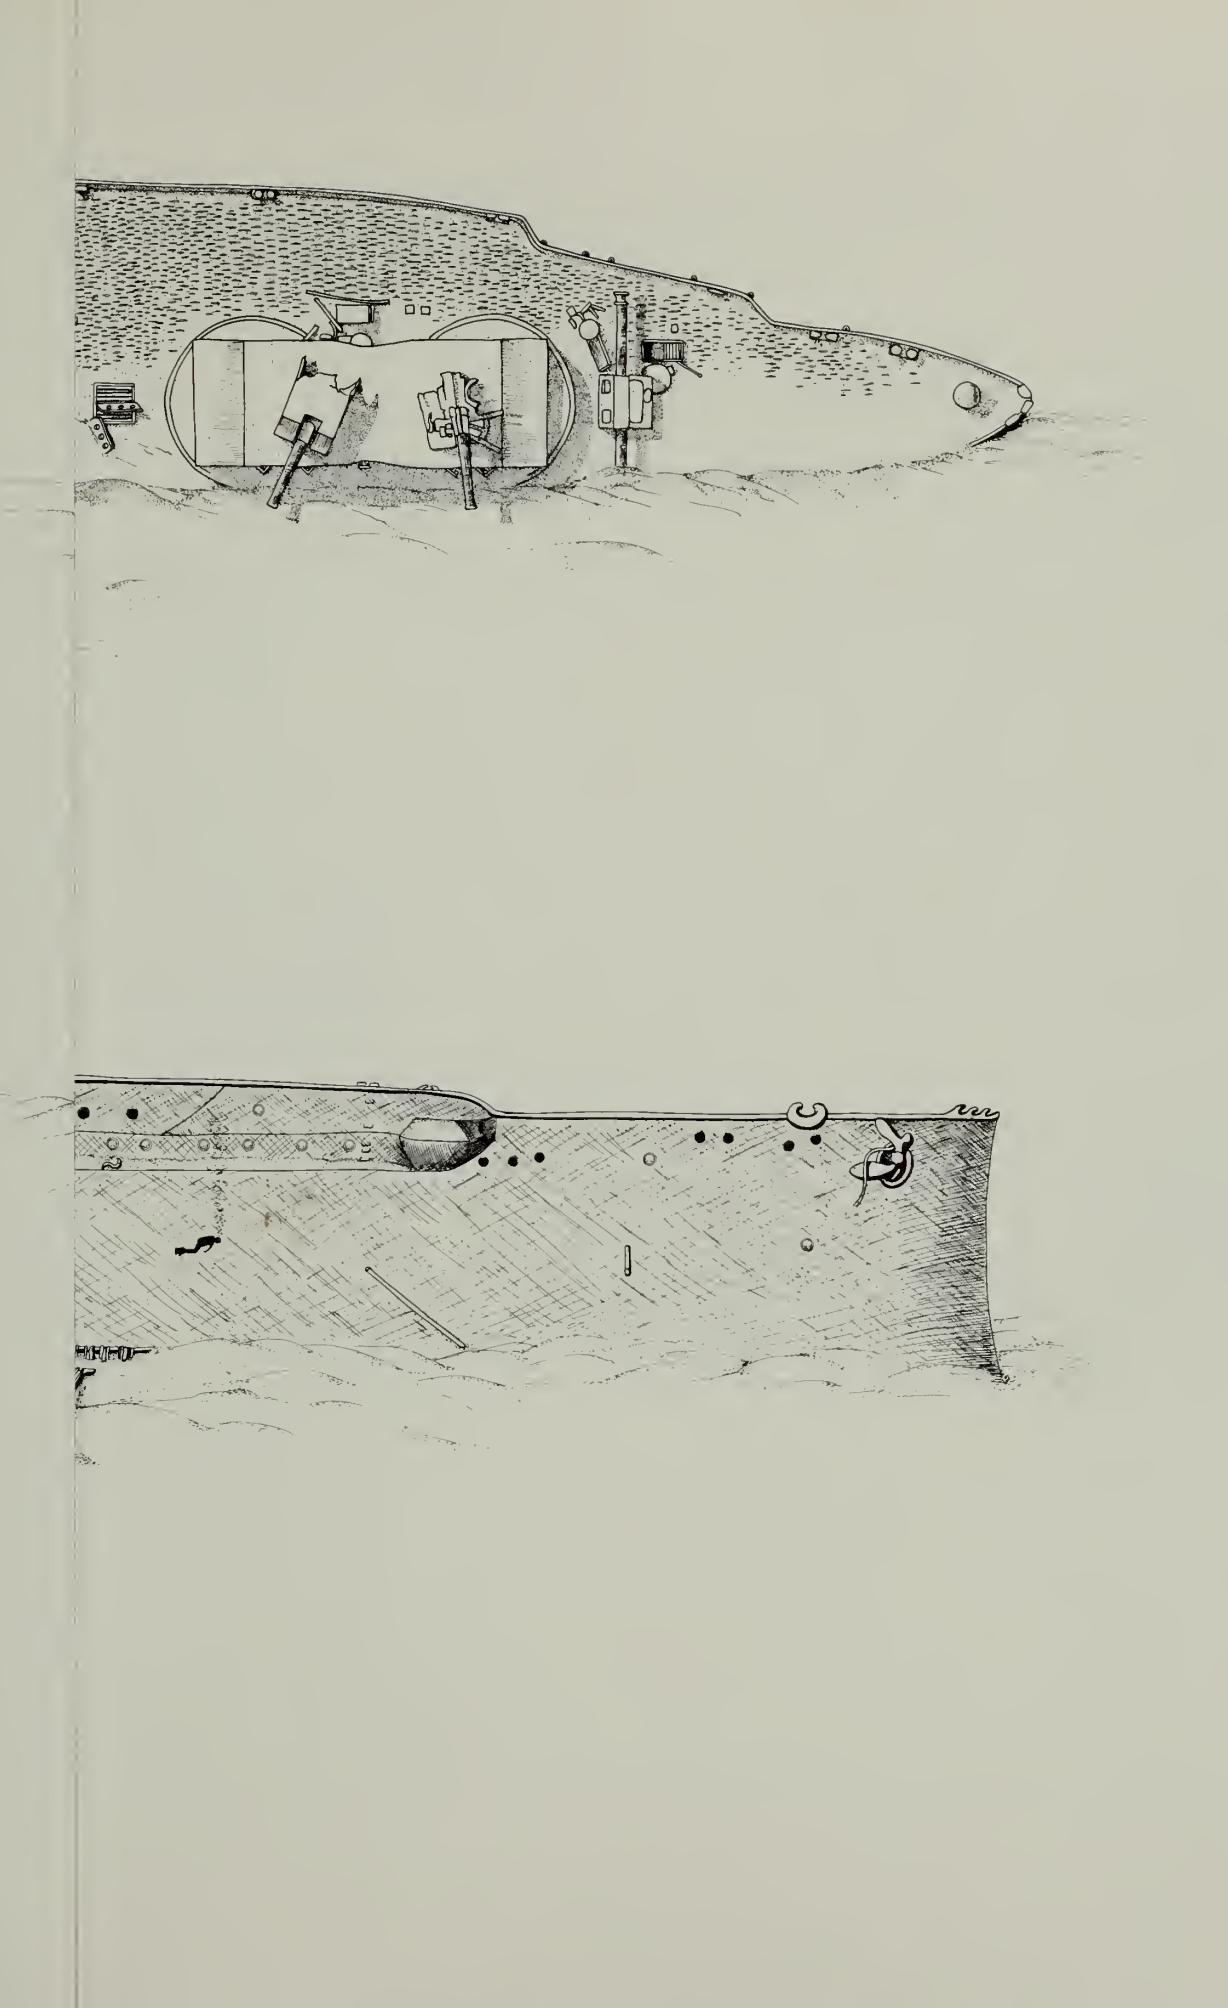
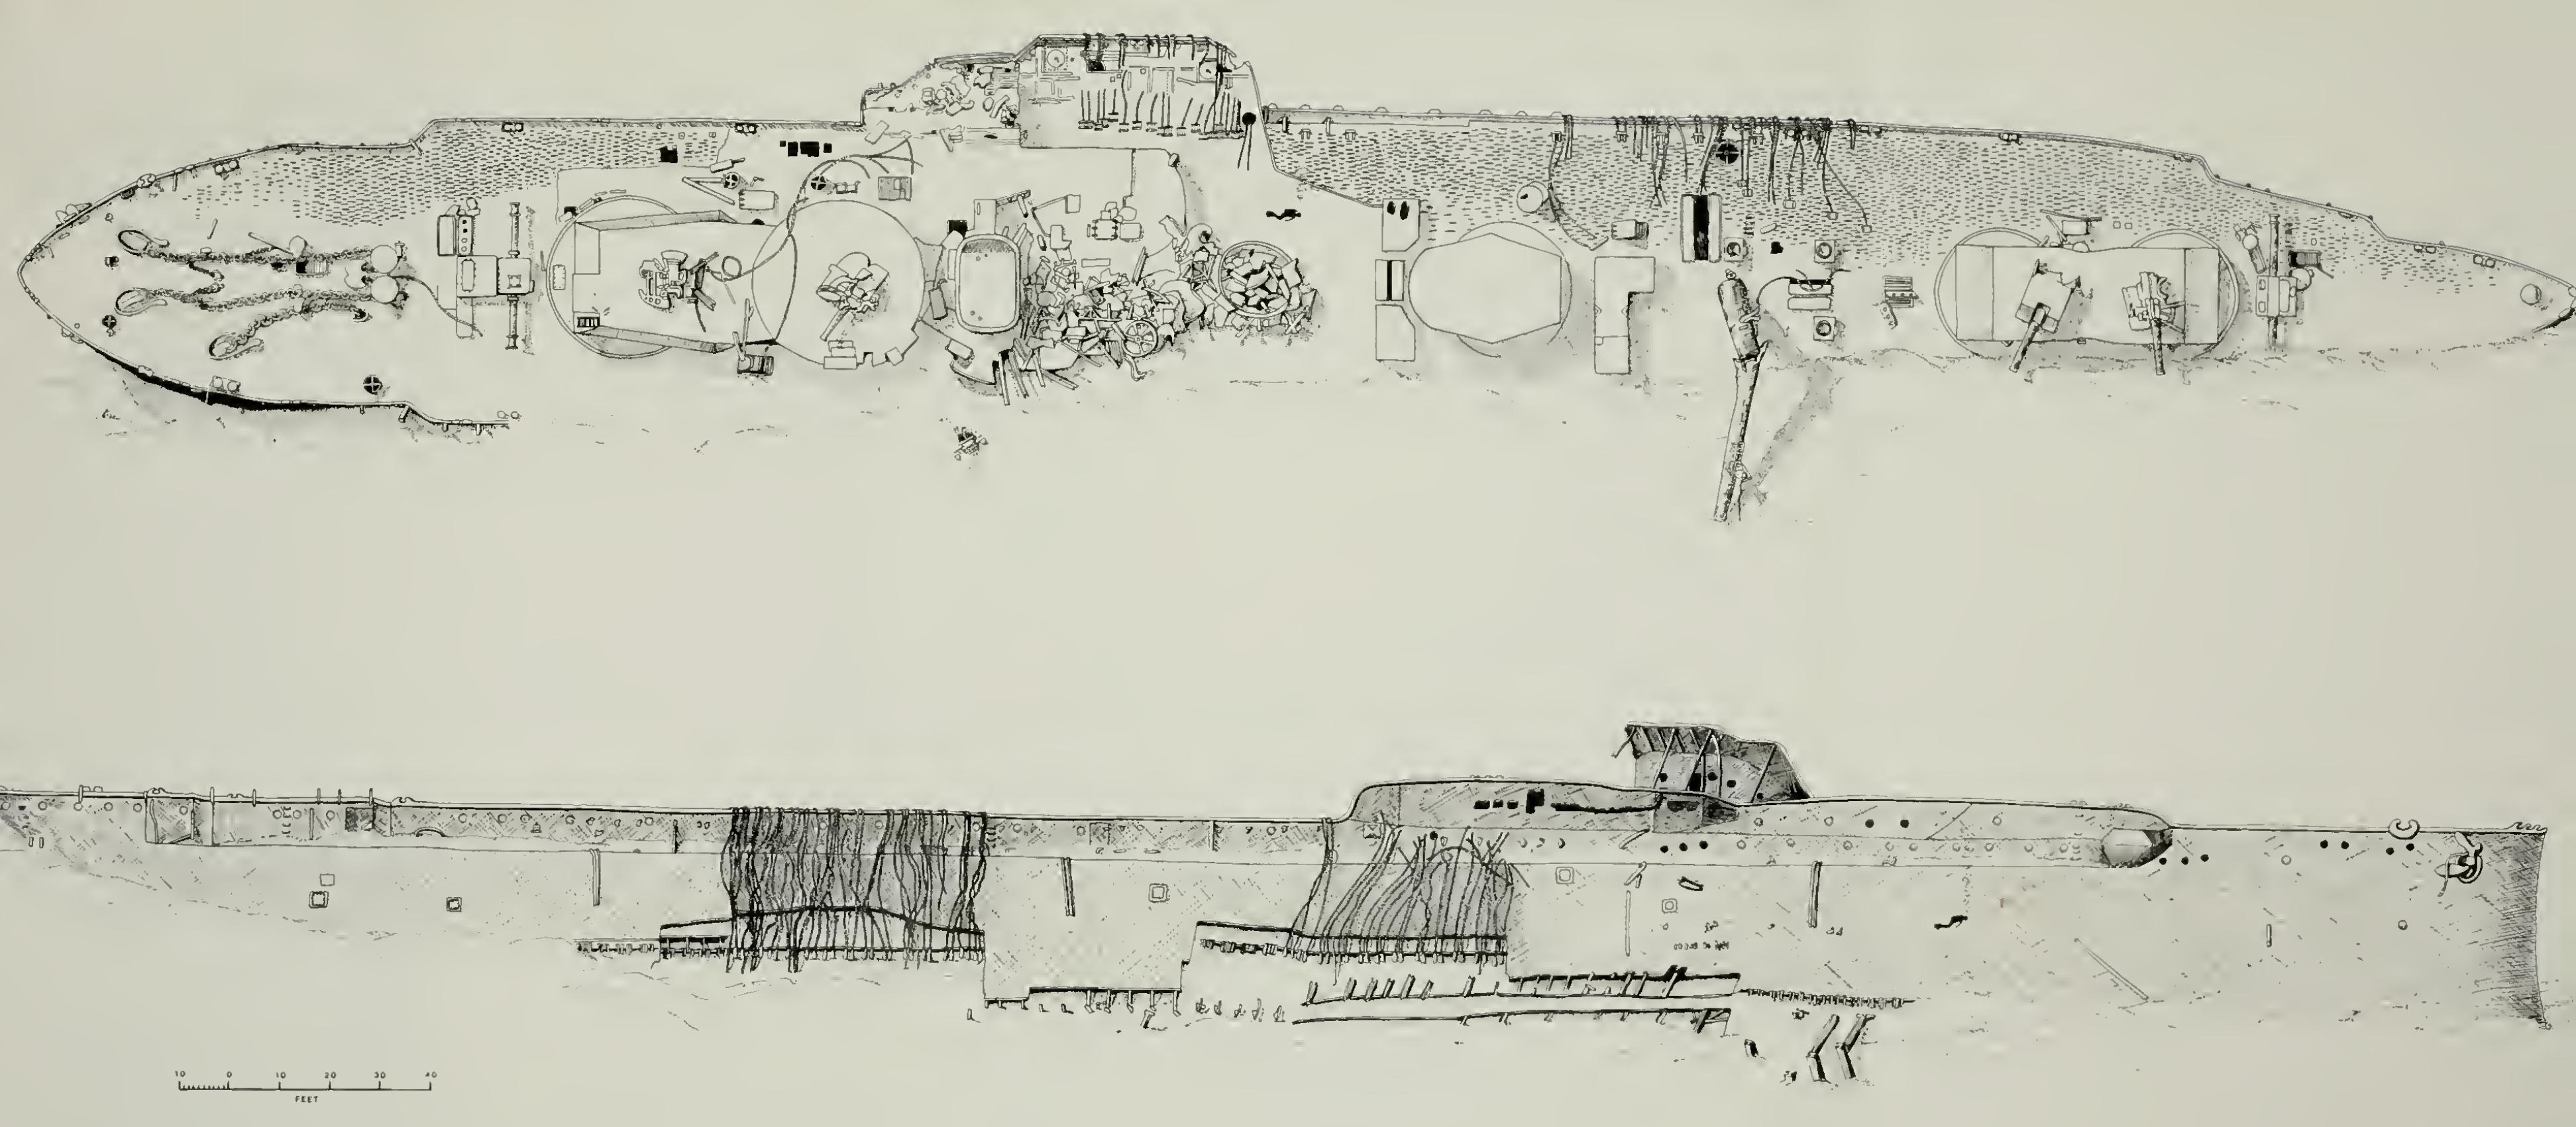
Perhaps the best way to pursue a descriptive narrative of the current condition of the UTAH underwater is to conduct an imaginary swim from bow to stern, first along the starboard side, and then along the deck (see Figure 3.33 --for reference).

Heading aft on the starboard side, one would probably first see the anchor still secure in the hawse pipe. From here aft there are very few features, except some intact portholes well above the waterline. No signs of war damage are evident, indicating that the torpedo damage on the port side that sank the ship did not vent on the starboard.

The hull is virtually complete and undistorted. Near the starboard bilge line, a hull plate has been removed. A-frame parbuckling gear (or righting headgear) was attached to the bottom of the UTAH during attempts to right the vessel. Cables attached to the parbuckles once led to huge electric winches on shore. It appears that

Figure 3.33. Two-part drawings of remains of USS UTAH. Drawn by Jerry Livingston from underwater operations conducted by SCRU and US Navy Reserve MDSU One (Det 319).

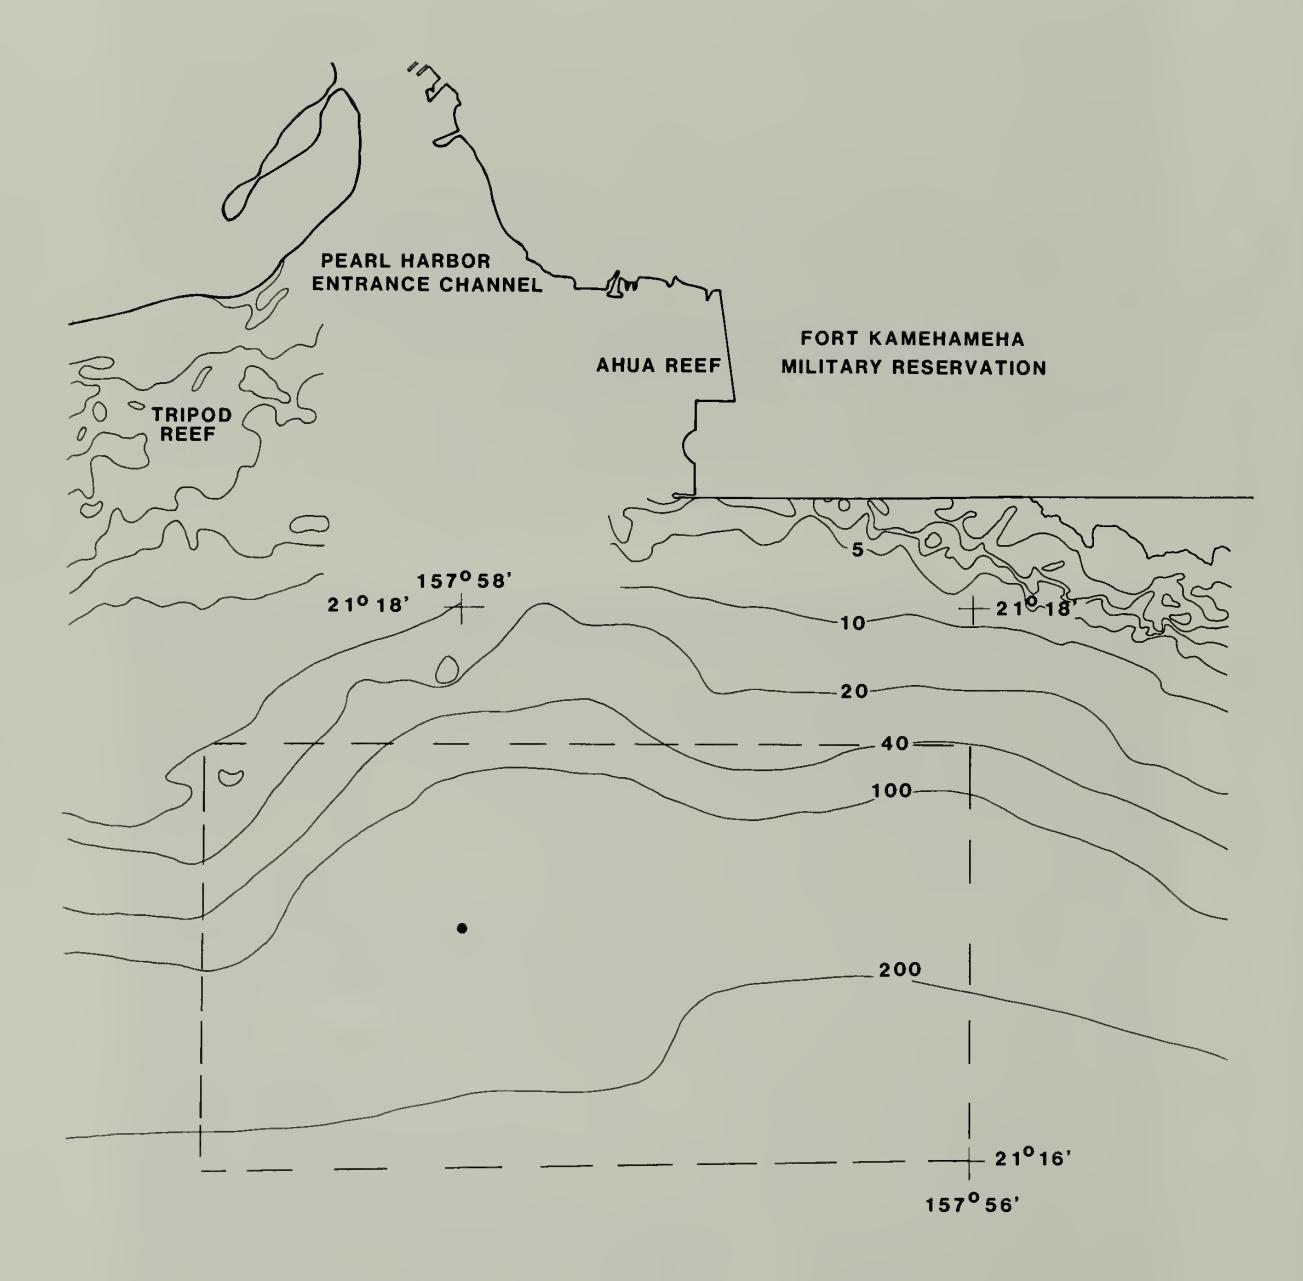
Figure 3.37. Chart of outer harbor defensive zone showing search area and contact location of possible Japanese midget submarine.

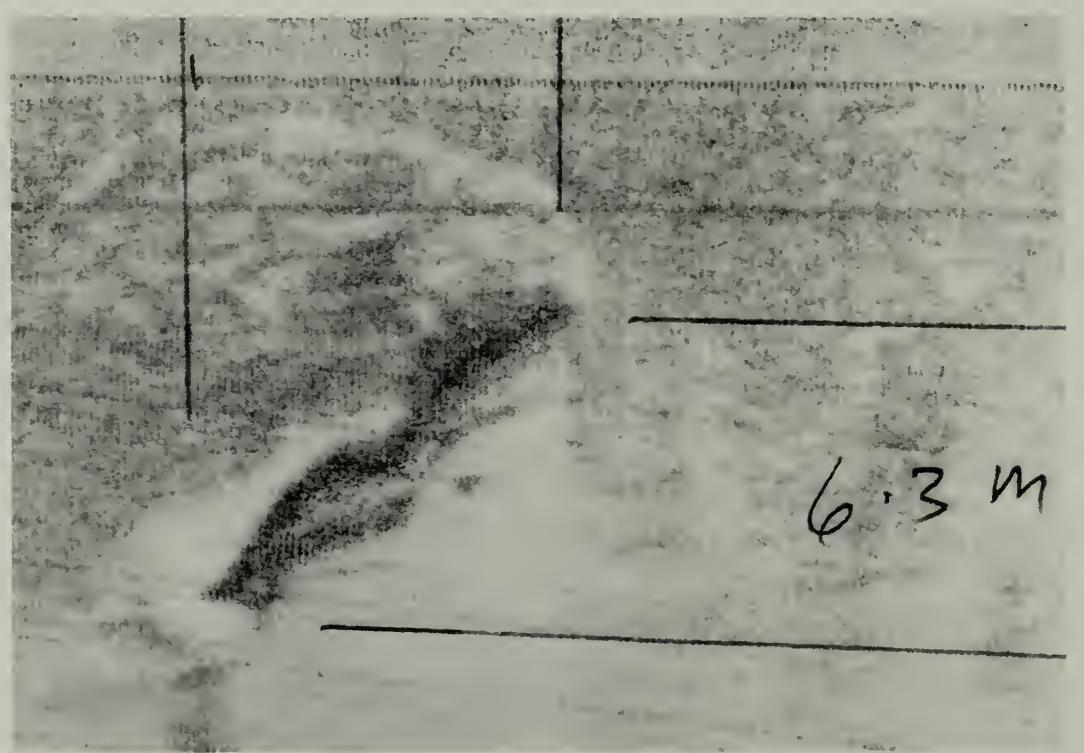
Figure 3.38. Side-scan sonar contact from NPS/Navy survey outside harbor mouth in almost 900 feet of water. (Photo of side-scan record by Mark Hertig)

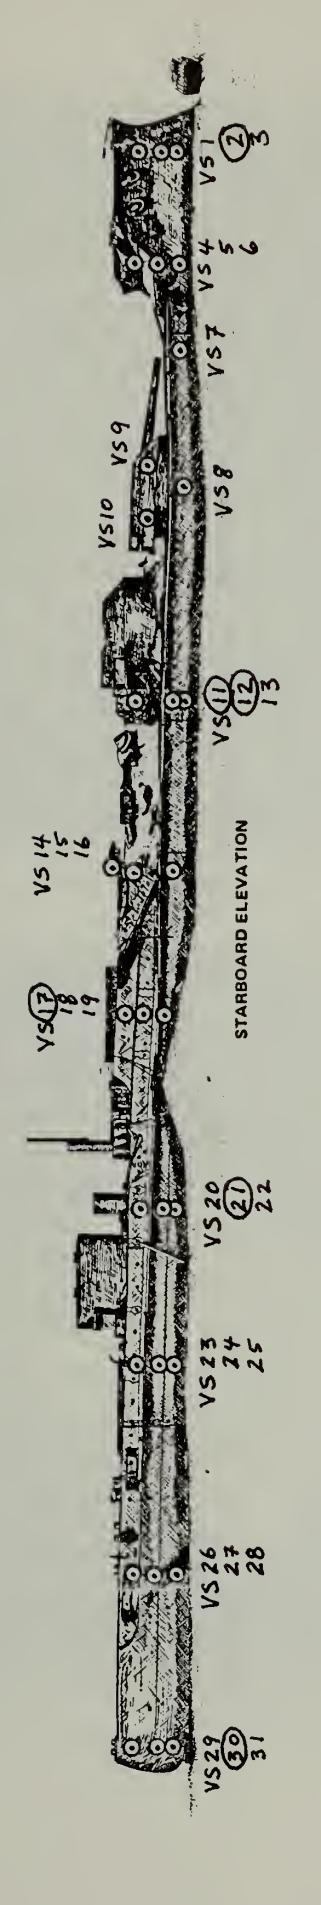
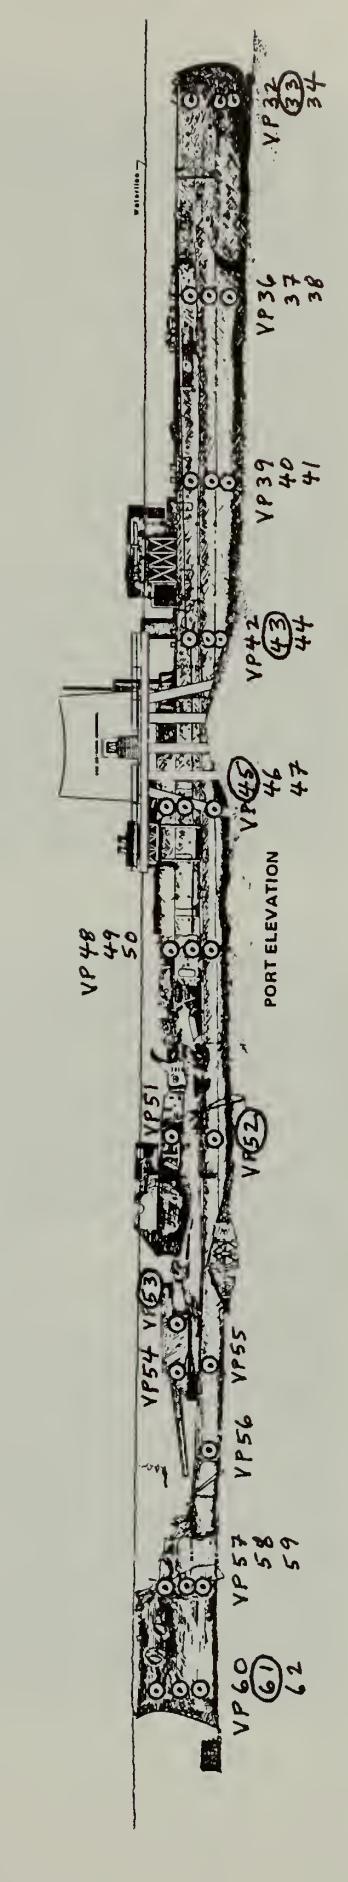
Sixty-one locations on vertical surfaces were tagged for examination and future monitoring. Vertical stations were generally positioned so that 10 vertical "transects" of three stations each were distributed about evenly over port and starboard sides of the ship (Figure 4.1). Most stations were located on the hull surface, but a few were positioned on typical superstructure surfaces. Depths of vertical stations varied from 7 to 32 feet.

Figure 4.1. Locations of vertical surface biofouling stations on the USS ARIZONA. Encircled station numbers denote permanently emplaced PVC studs for photo monitoring.

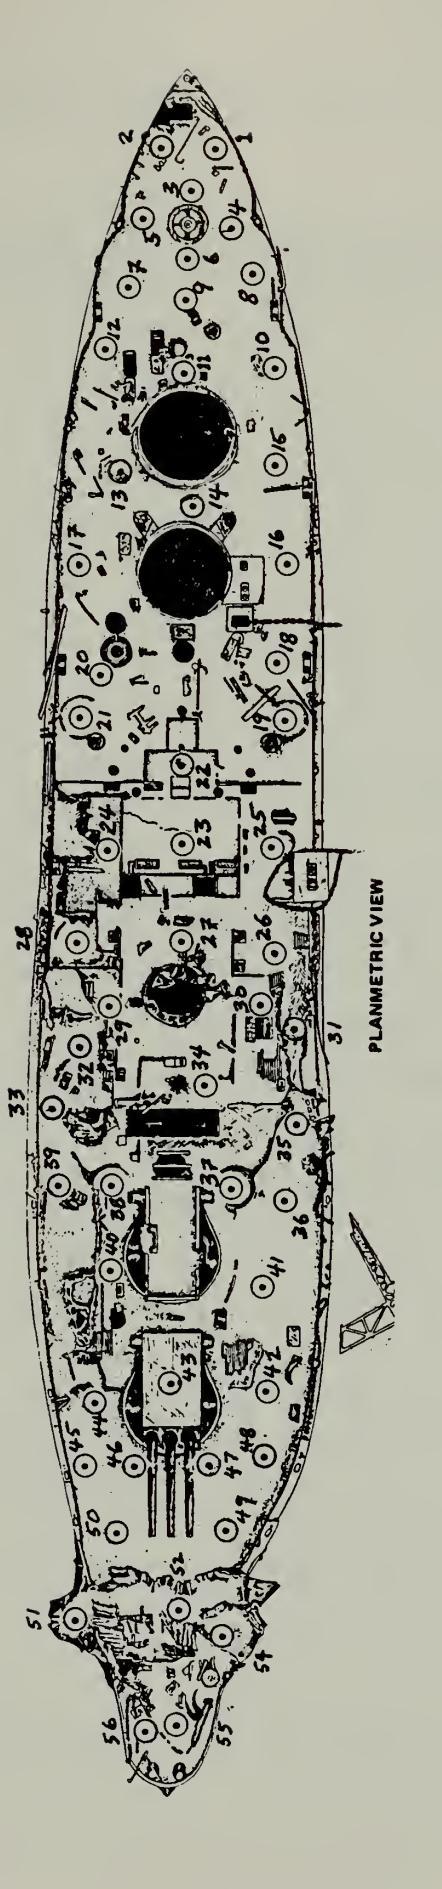
Fifty-five locations on horizontal surfaces of the ship were marked for examination of sediment type and depth (Figure 4.7). Because most of the ship's superstructure had been removed in the salvage operations, most of the study stations had to be situated over main deck surfaces, primarily of teak wood. Station depths ranged from 5 to 18 feet.

Aft area, about 40 percent of ship length (Stations 1 through 22). This area lies in an average depth of 8 to 10 feet. Sediment is generally 1 to 6 inches deep and is characteristically about 50 percent sand, 20 percent rubble, and 10 percent mud/silt. The sediment is held together in a spongy mat by pervading growth of colonial feather-duster worms (Branchiomma cingulata) and sponges. Large feather-duster worms (Sabellastarte sanctijosephi) inhabit the sediment in densities of about 1 to 5 per square meter. Encrusting and erect spon-

Locations of horizontal surface monitoring stations on the USS ARIZONA. Figure 4.7. Station 1

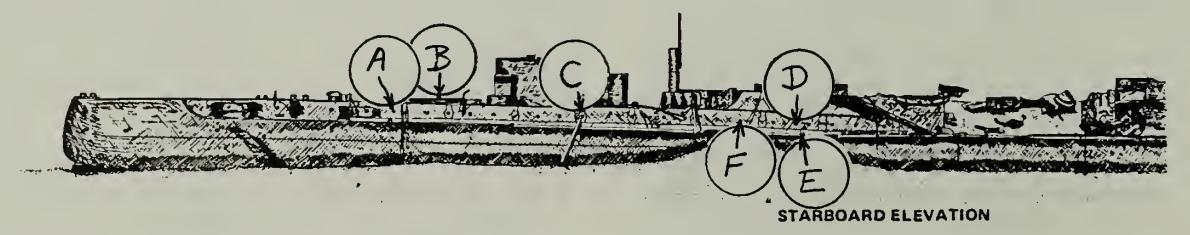
As expected, oxygen levels measured 15 to 16 feet inside interior spaces were substantially lower than ambient values (Table 4.5). At distances of 8 to 9 feet inside openings, oxygen levels were only moderately lower than ambient, indicating that water volumes within about 10 feet of hull openings are relatively well flushed. Oxygen concentrations were at or less than 1 mg/l at 15-foot distance from opening in 3 out of 6 stations, thus it would be reasonable to assume that most other enclosed volumes in the hull that are distant from openings would also exhibit sub-1 mg/l oxygen concentrations.

Figure 4.9. Locations of points of entry for water -quality measurements made in interior spaces in the USS ARIZONA.
